## **Composite Failure Analysis Handbook Update #1**

*Greg Walker*

*Boeing Defense & Space Group*

**April 1995**

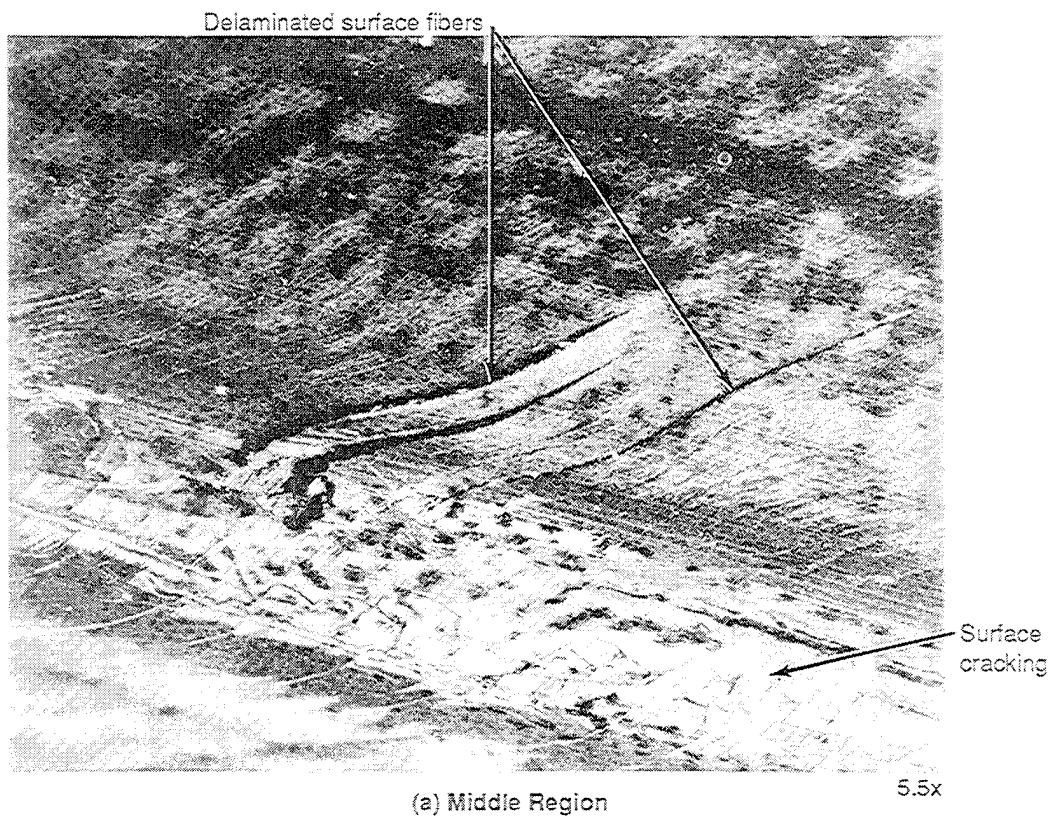
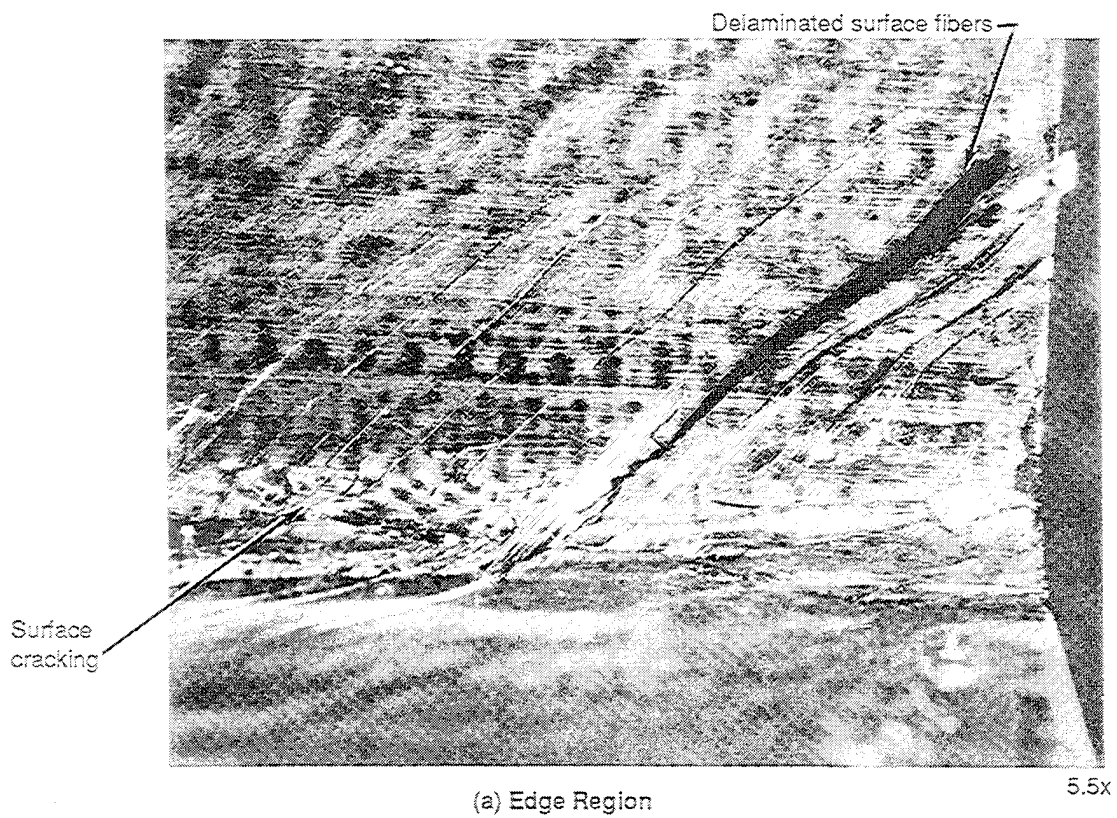
Surface fibers within the inner radius of the "knee" were cracked (fig. 4). Deformations, such as rippling and buckling, were also present along the entire length of the inner radius of the knee. Small indentations and elongated depressions or "tracks" were present along the inner knee surface (fig. 5). The surface of the depressions was shiny indicating that the depressions probably occurred during the fabrication process. Some of the "tracks" contained cracks which went through the surface ply. There were no surface defects or anomalies on the outside surface of the component. Strain gages were located on both sides of one of the flanges.

Figure 4. Micrographs Showing Regions of Surface Fibers Delamination and Cracking Along the Middle and Edges of the Inner Radius

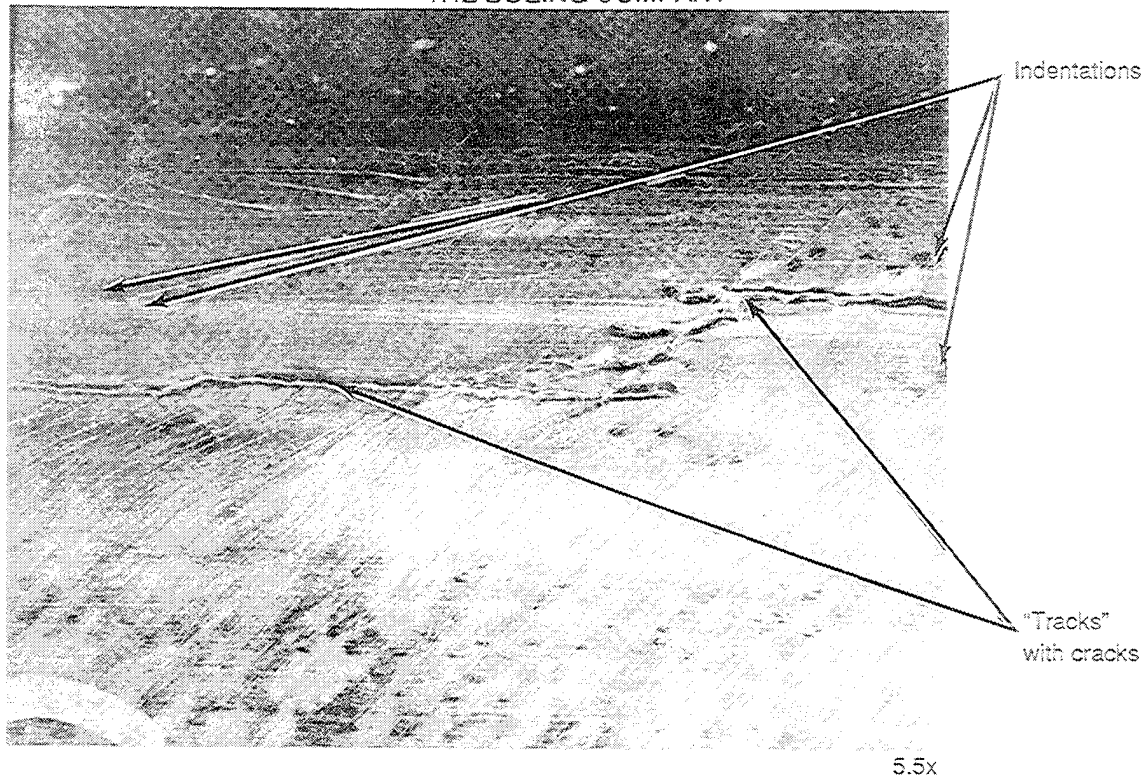
Figure 5. Micrograph of the Indentations and "Tracks" Along the Inner Radius

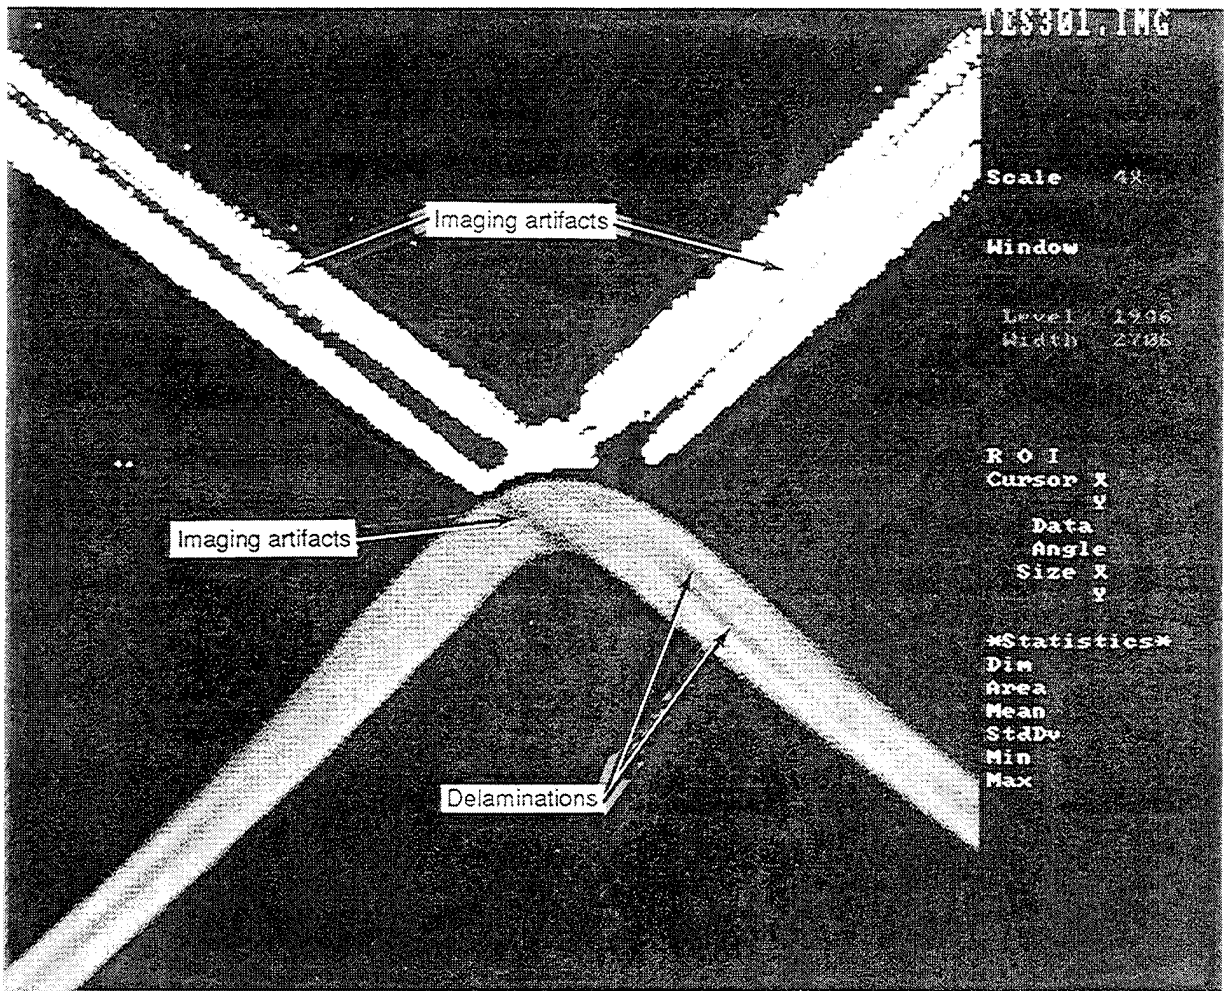
Figure 6. CT Image Showing the Imaging Artifacts and Some of the Actual Delaminations

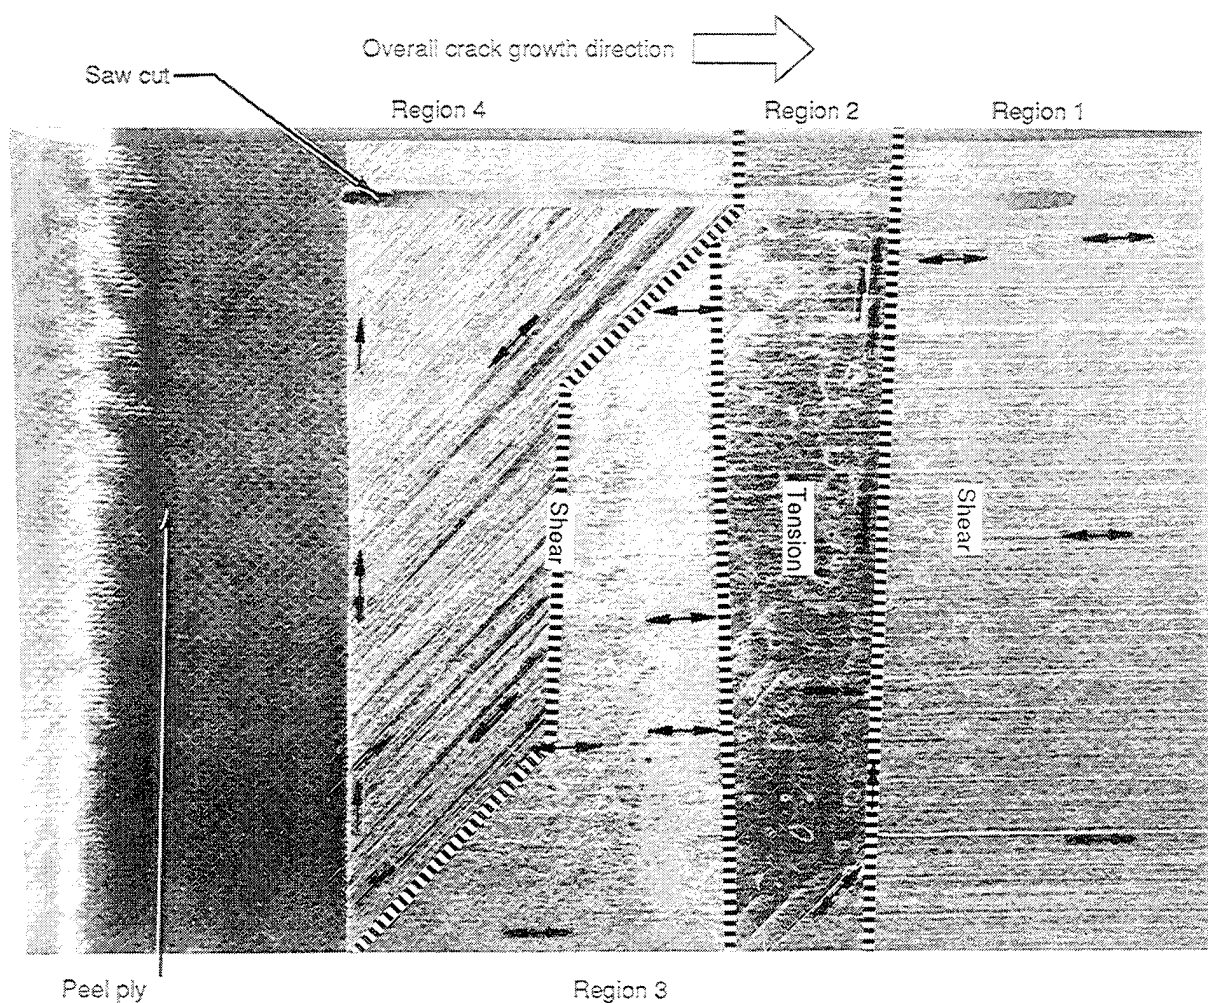
Initially, the component was gripped at the edges of the flanges using the fastener holes. As loading began, one edge was pulled away from the other edge which induced an initial shear loading condition inside the component at the edge of the peel ply. The presence of the peel ply in the center (where the maximum shear stress occurred) provided a high stress concentration region which allowed the cracks to initiate. As the edges were pulled further apart, the cracks continued to propagate by shear.

Note: Four regions are identified, exhibiting two different fracture modes:

- Region 1: Mode II (shear)
- Region 2: Mode I (tension)
- Region 3: Mode II (shear) 0-degree fibers
- Region 4: Mode II (shear) 45-degree fibers

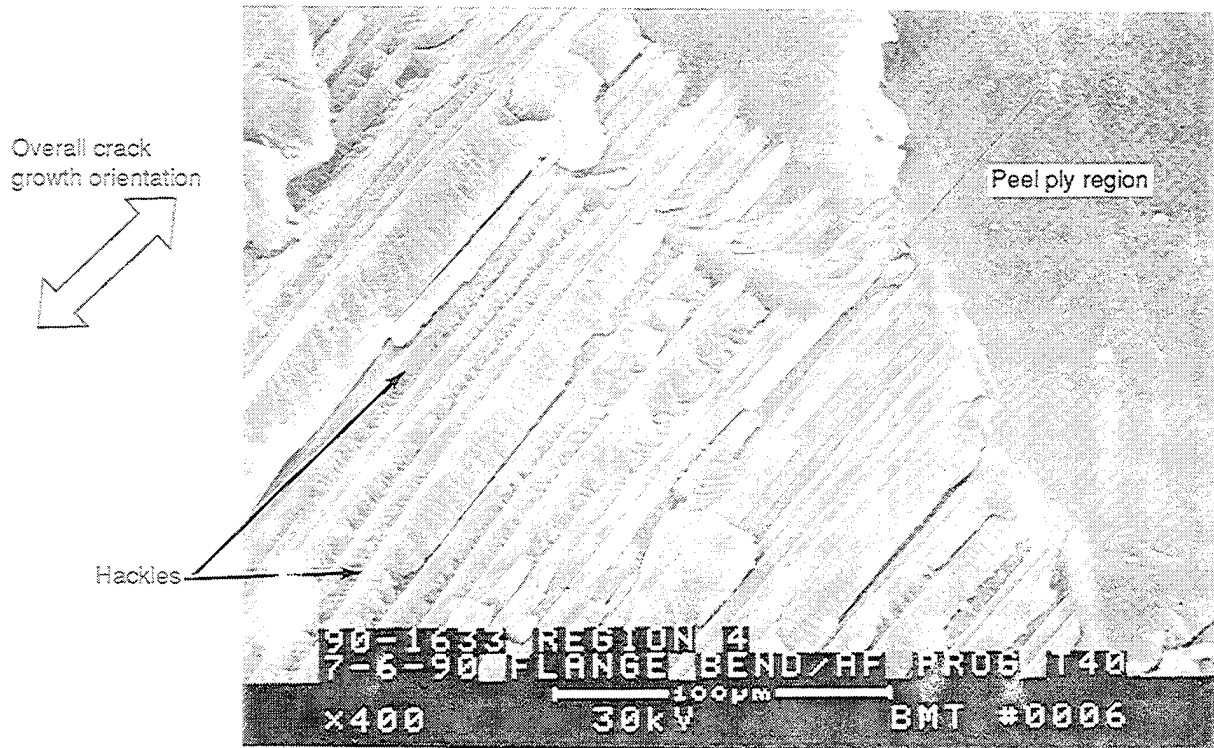
For the one flange, the crack propagated entirely by shear. However, the cracking on the other flange changed modes because the stress orientation had altered significantly enough, due to the component's deformation, to continue the shearing mechanism. As a result, localized buckling occurred which caused a change in the propagation mode from shear to tensile. After further displacement, deformation of the part again changed the loading orientation which changed the propagation mode back to the more energetically favorable shearing mode. Also, the stresses were now sufficient at this point to cause additional delaminations to initiate and propagate in the knee region. This continued until the crack reached the gripped region which was clamped and restricted further crack propagation.

Figure 14. SEM Micrograph of a Mode II-Type (Shear) Fracture Surface in Region 4 Adjacent to the Peel Ply

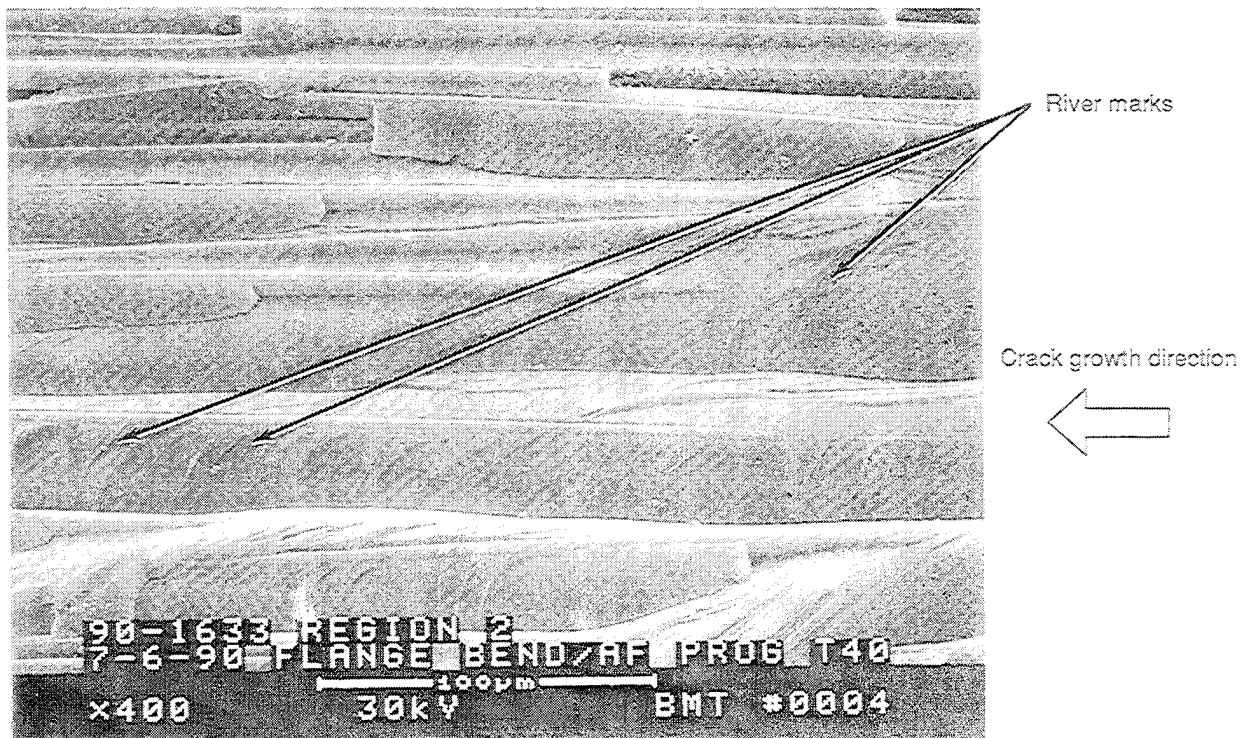
Figure 15. SEM Micrograph of a Mode I-Type (Tension) Fracture Surface in Region 2

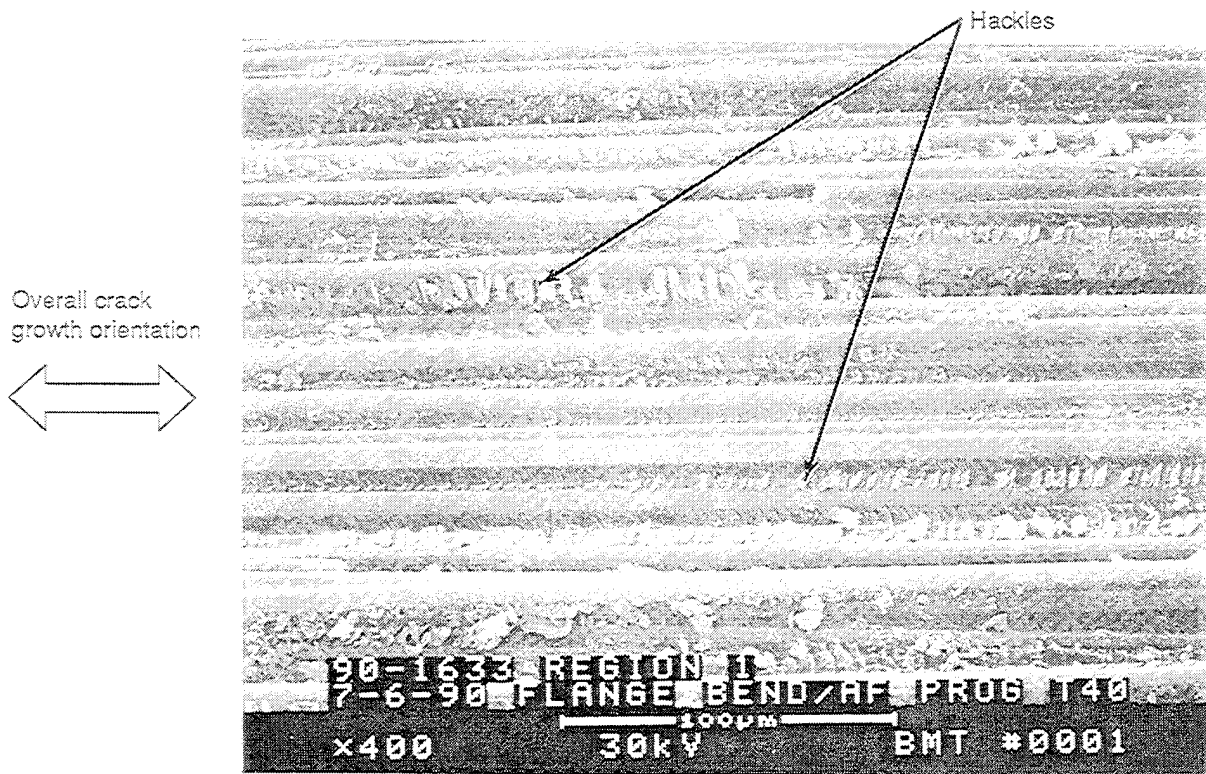
Figure 16. SEM Micrograph of a Mode II-Type (Shear) Fracture Surface in Region 1

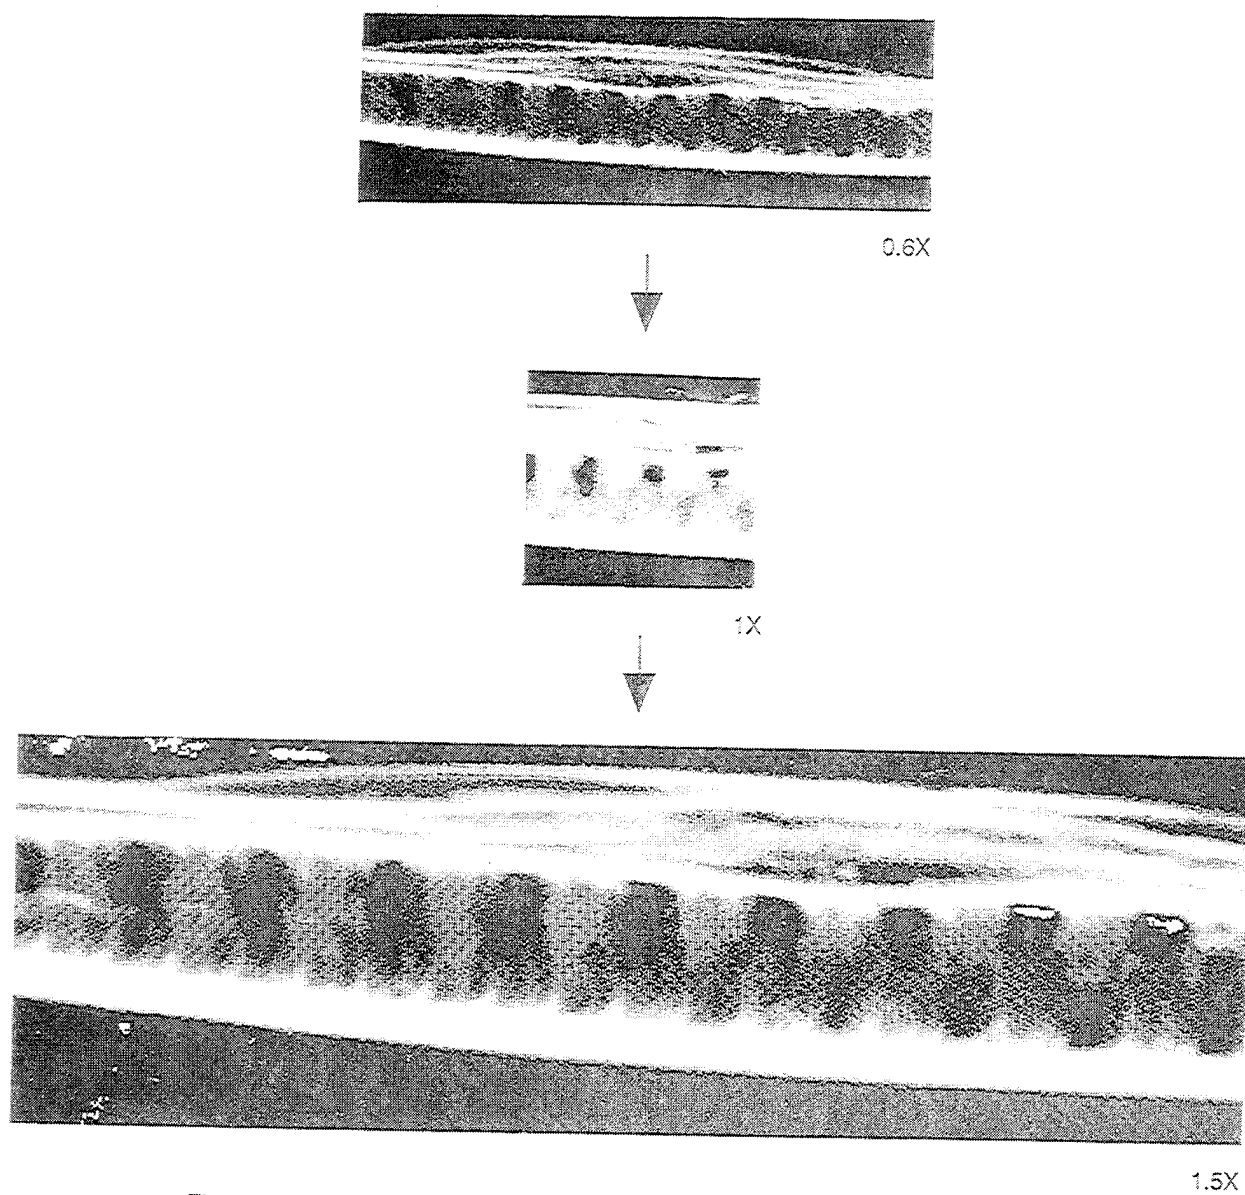
Figures 8 through 11 show the various images of the slices through the component. The longitudinal slices 1, 2, & 3 show the damage present in the honeycomb regions in the center of the component. The front half of the panel appears to have been crushed by a macroscopic shearing of the upper front half of the facesheet. The back half exhibited little if no damage. However near the bulge, the core appeared to be crushed in the short transverse direction. There was no evidence showing any longitudinal buckling trends to either end (from one end to the other). This transverse damage was located all along the back half of the component.

Figure 8. CT Images of the Transverse Scan Through the Delaminated Zone

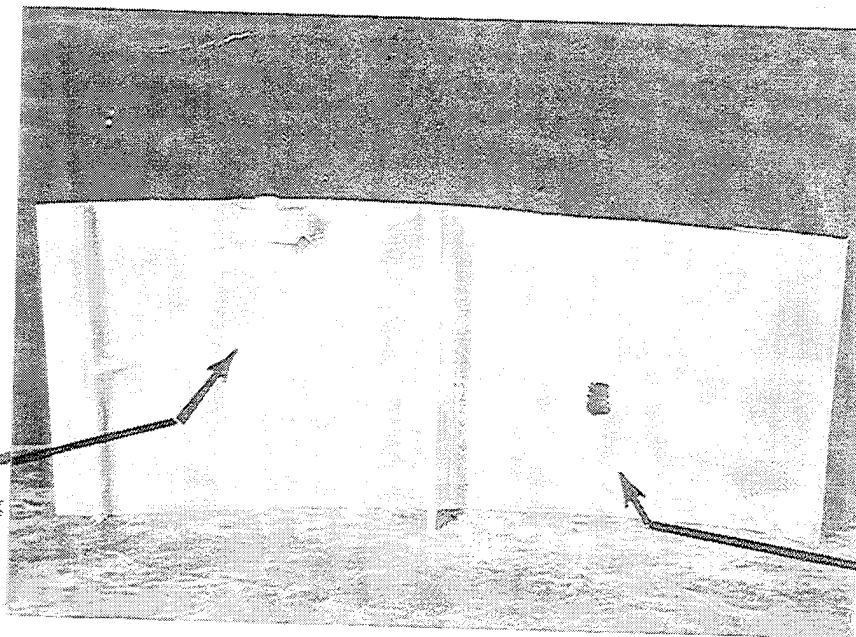
large delaminated  
region corresponding  
to a sanded region  
on the outer surface

*Figure 3. Photograph of the Inner Surface of the Upper Wing Surface*

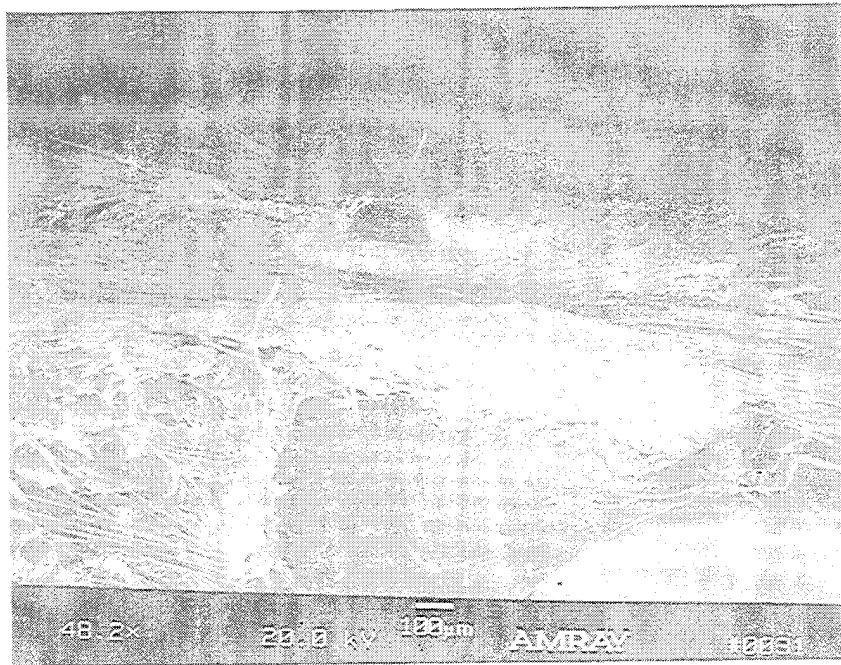
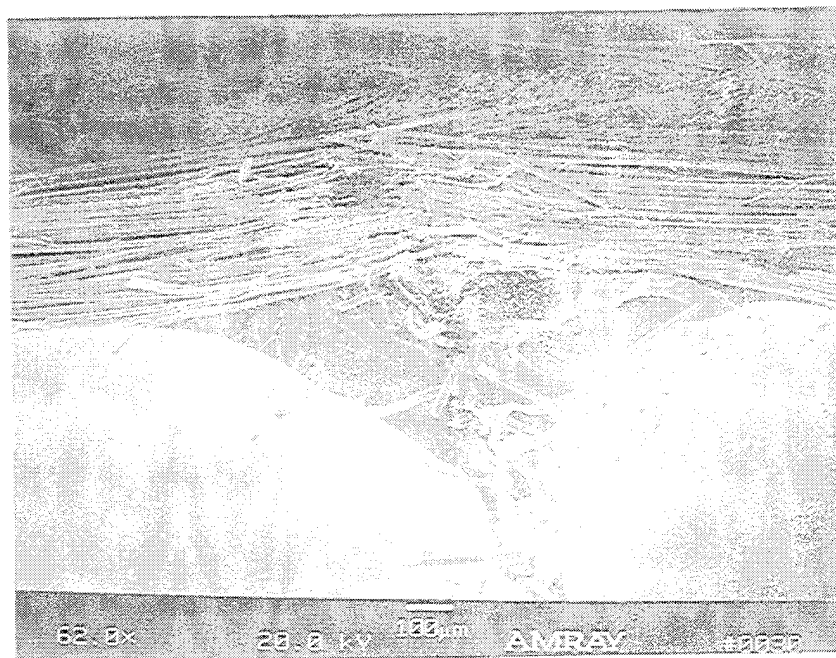
Figure 12. SEM Photographs of the Crack Surfaces

feature on the both the fibers parallel and perpendicular to the crack were the hackles indicating a mode II (shear) loading.

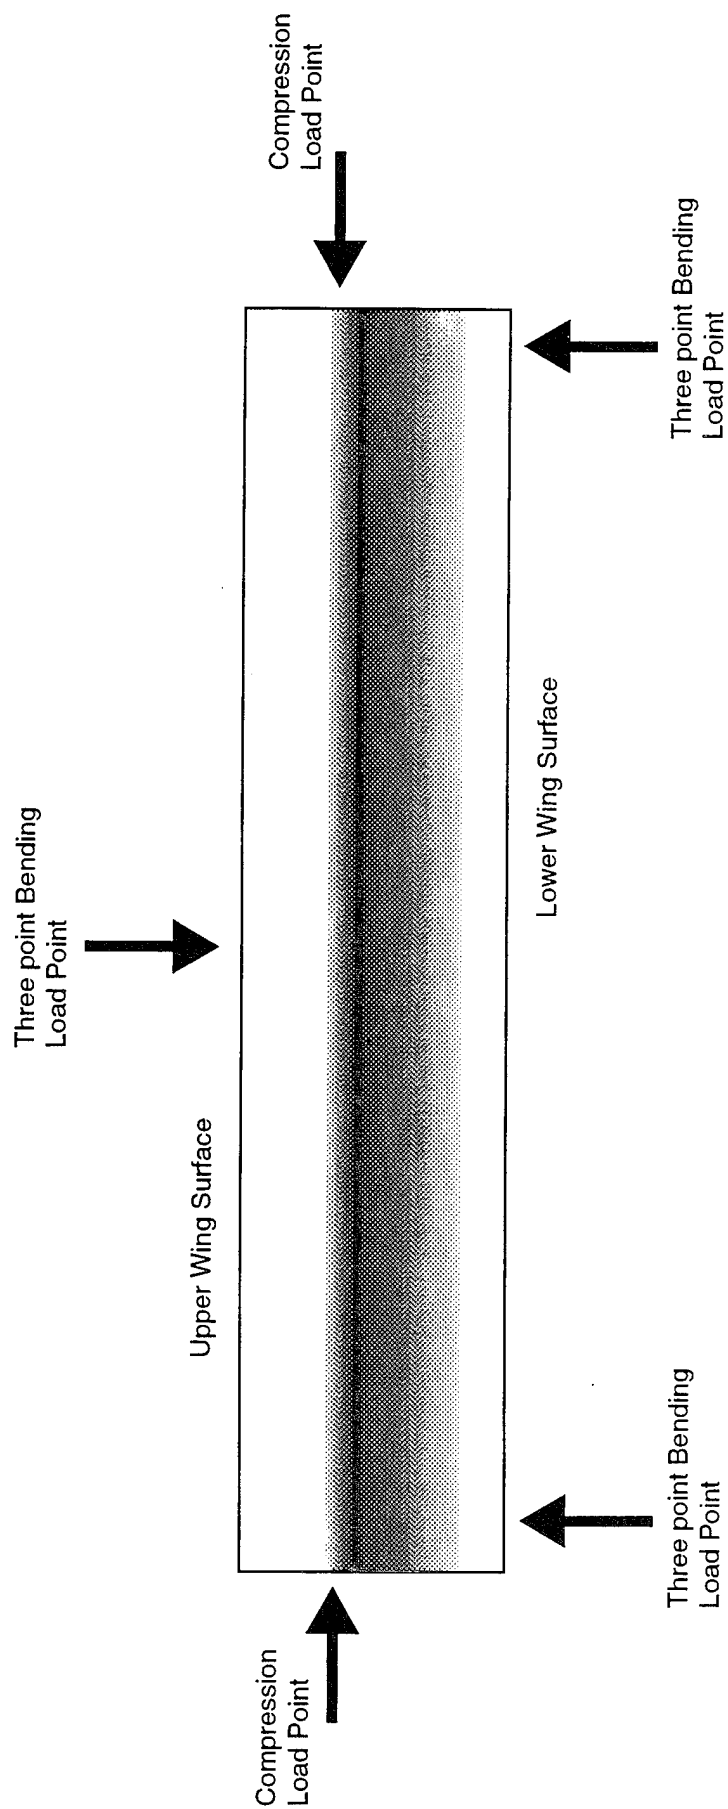
1. The wing section contained two major cracks which extended from the leading edge of the wing to the aft edge. Another small crack was located at the edge, in the middle of the wing section. All of the cracks were on the upper wing skin.
2. Chemical analysis of the materials did not reveal any anomalies in the materials. No material or fabrication anomalies which could have contributed to crack initiation were found.
3. Cross-sectional and SEM analysis revealed the fractures were caused by buckling of the upper skin. The specific cause of the bucking could not be determined.

Figure 13. Diagram of the two Proposed Loading Configurations Which could Cause the Upper surface to Buckle
